Hydraulic Company of America

JR-33 TWINPAK

Installation/Operating Instructions

JR-33 Transfer Valve

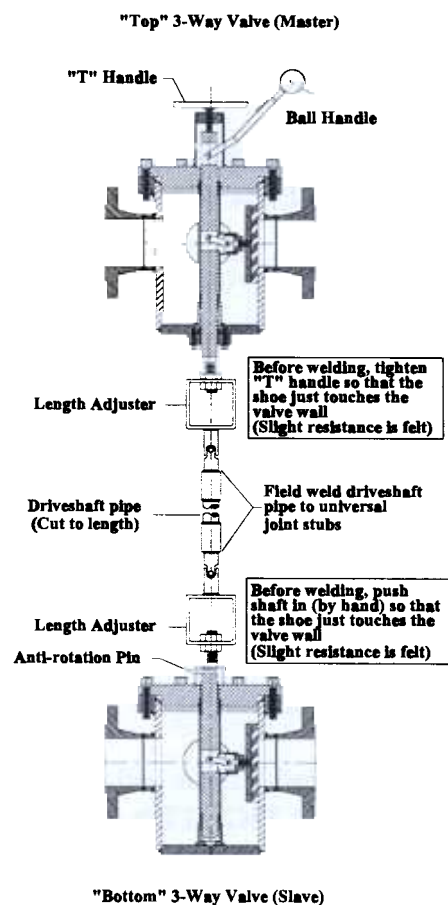
TWINPAK

- Install both JR-33 3-way valves between the heat exchangers or filters and tighten the flange bolts.
- .2 Set the shaft position on the (master) 3-way valve by tightening the "T" handle until the elastomeric port seal shoe just contacts the valve body wall. This point while having no visual indication, can be felt by a slight increase in the torque required to rotate the tee handle.

- .3 Phase the bottom (slave) 3-way valve shaft, relative to the master 3-way by rotating the slave shaft so that the anti-rotation pin is directly under the loop handle on the master 3-way. Manually push the shaft into the valve (it should move easily) until resistance of the shoes against the body is felt.

- 1.4 Position the square length adjusters on both master and slave shafts so that they are midway along the threaded part of the valve shafts. Tighten the hex locknuts against both sides of both length adjusters.

- .5 Cut the driveshaft pipe to final length, slip into place and weld.
 - .6 Fill system and test for failure to isolate. If failure to isolate is detected, a minor adjustment to the driveshaft length is needed.
